Final Report  
for  
Comprehensive Lake Management Planning Grant  
Project #LPL162317  
**Forestville Millpond**

June 2018

**Door County**

**Soil and Water Conservation Department**

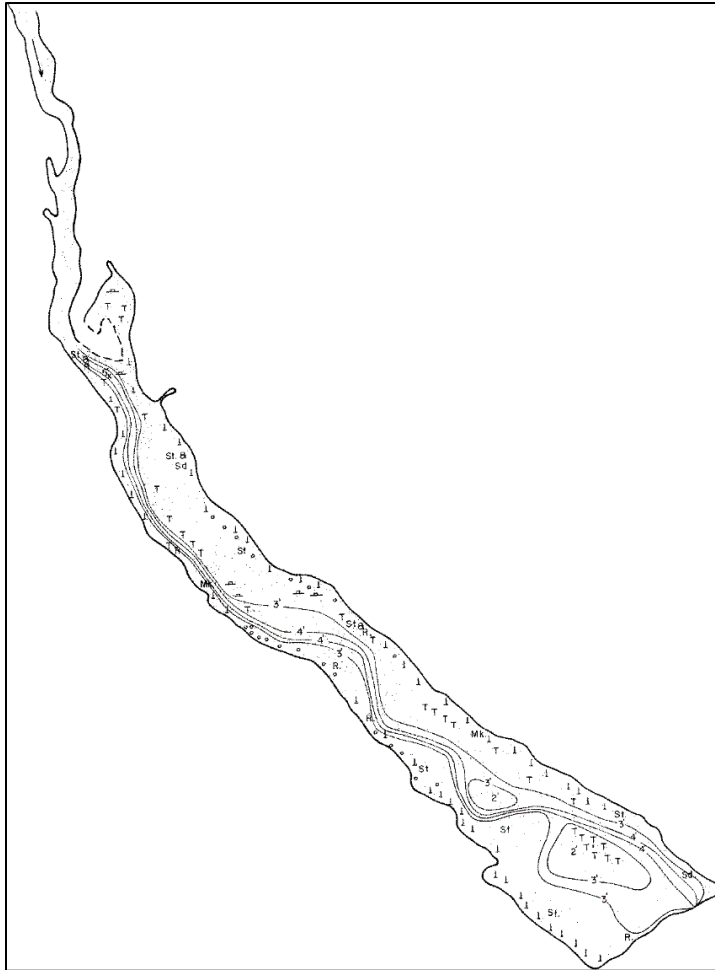
Figure 4-1. 1974 Bathymetric Map – Wisconsin DNR

The last complete bathymetric survey of the Forestville Millpond was conducted in 1974 (see Figure 4-1).

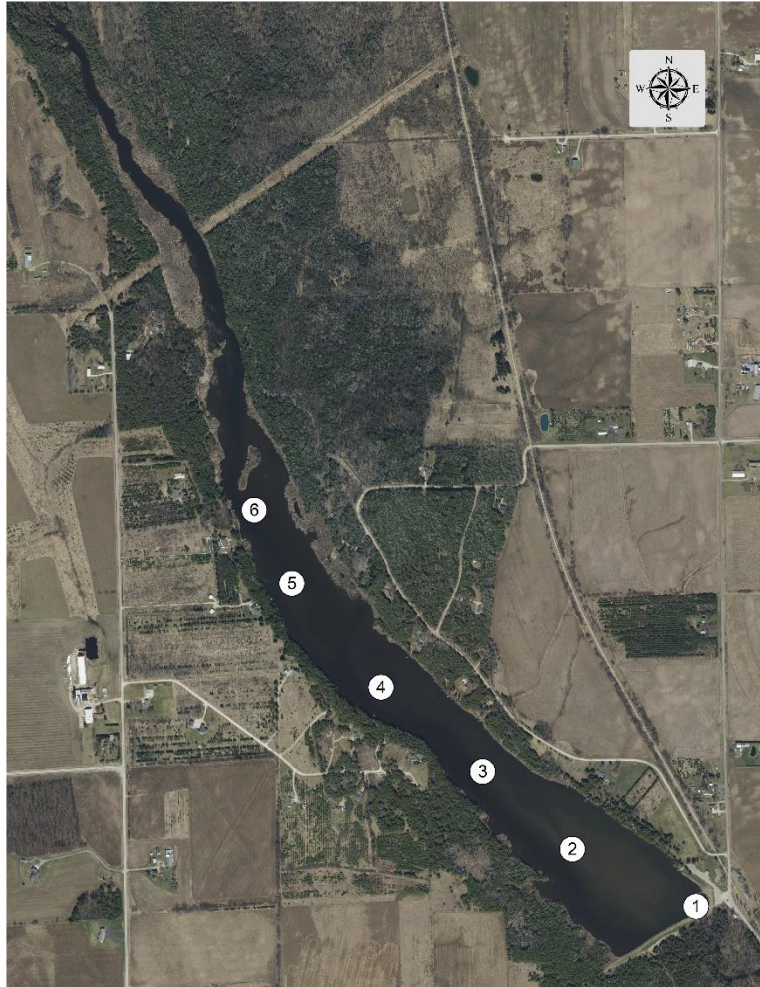
Figure 6-1. Location of Sediment Cores

Six coring locations were identified (see Figure 6-1) and a plan which outlined procedure and analysis to be done was submitted to the Wisconsin Department of Natural Resources for review. Locations were chosen to provide a representative assemblage of the Millpond sediment. A partnership of the SWCD and UW-Oshkosh staff collaborated on October 31 and November 5 of 2017 to collect the samples. A Livingstone-type rod piston corer was used with split tubes to extrude the cores for visual inspection and collection of sample material (see Figure 6-2).

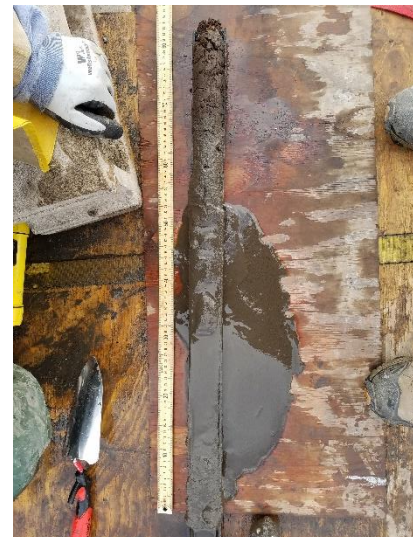
Figure 6-3. Sediment Core #3

Each core was examined for stratigraphic layers, and representative samples for analysis were taken from each layer. Each sample was split into three layers with the top being loose unconsolidated material, the middle “muckier” sediments and the bottom layer was more compact (see Figure 6-3).
