**Evaluation of the Forestville Millpond Following an Extended
Drawdown**

Project #LPL185623

The Door County Soil & Water Conservation Department

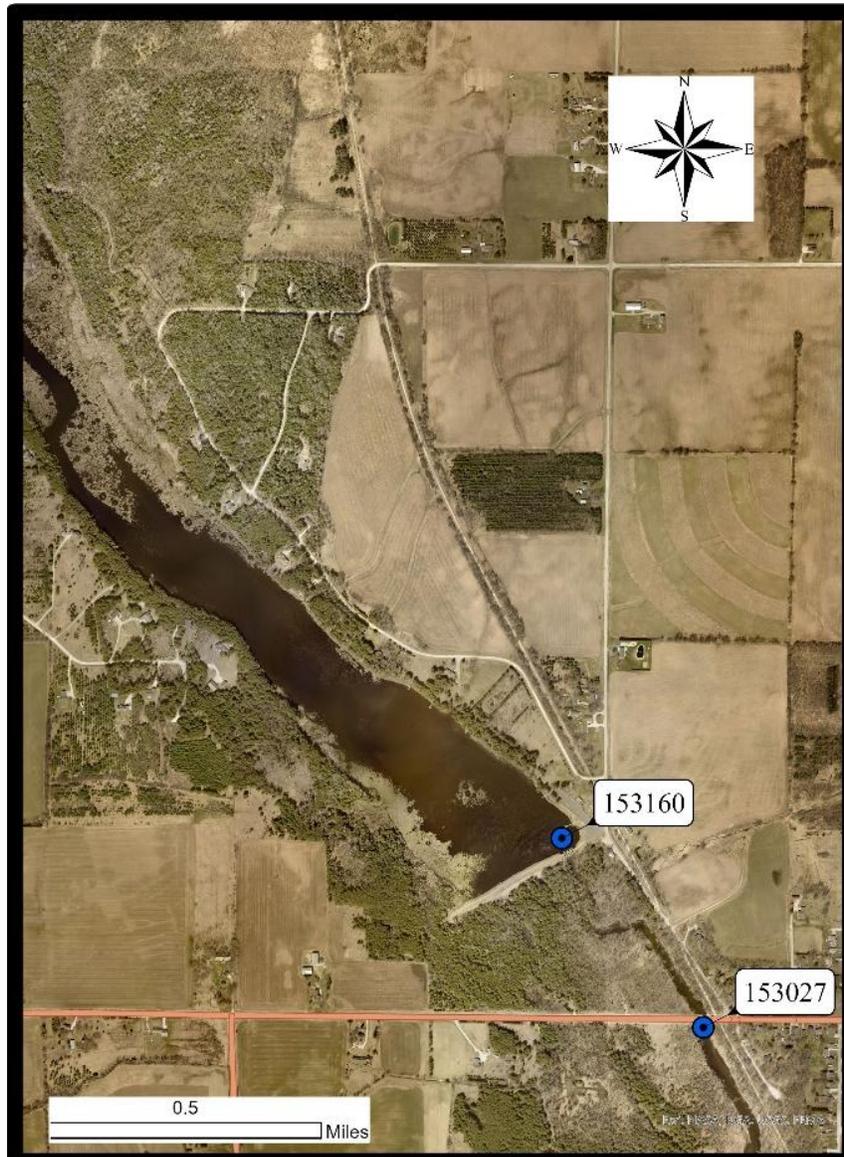
Figure 2. Sampling sites at the Forestville Millpond and in the Ahnapee River below the Forestville Dam.

The sample location in the Millpond (site #153160) was located directly above the dam (Figure 2). This site was also sampled three times in 2023: 6/14, 7/17, 8/16. The same field measurements were conducted by the team from UWO, where they measured temperature, DO, pH, and TSS, in addition to turbidity during the sampling dates of 7/17 and 8/16. Water from this site in the Millpond was collected and sent to the Wisconsin State Lab of Hygiene for TP and chlorophyll-*a* analysis on all three sampling dates, along with Kjeldahl Nitrogen and Nitrate+Nitrite (as N) analysis on the sampling date of 6/14.

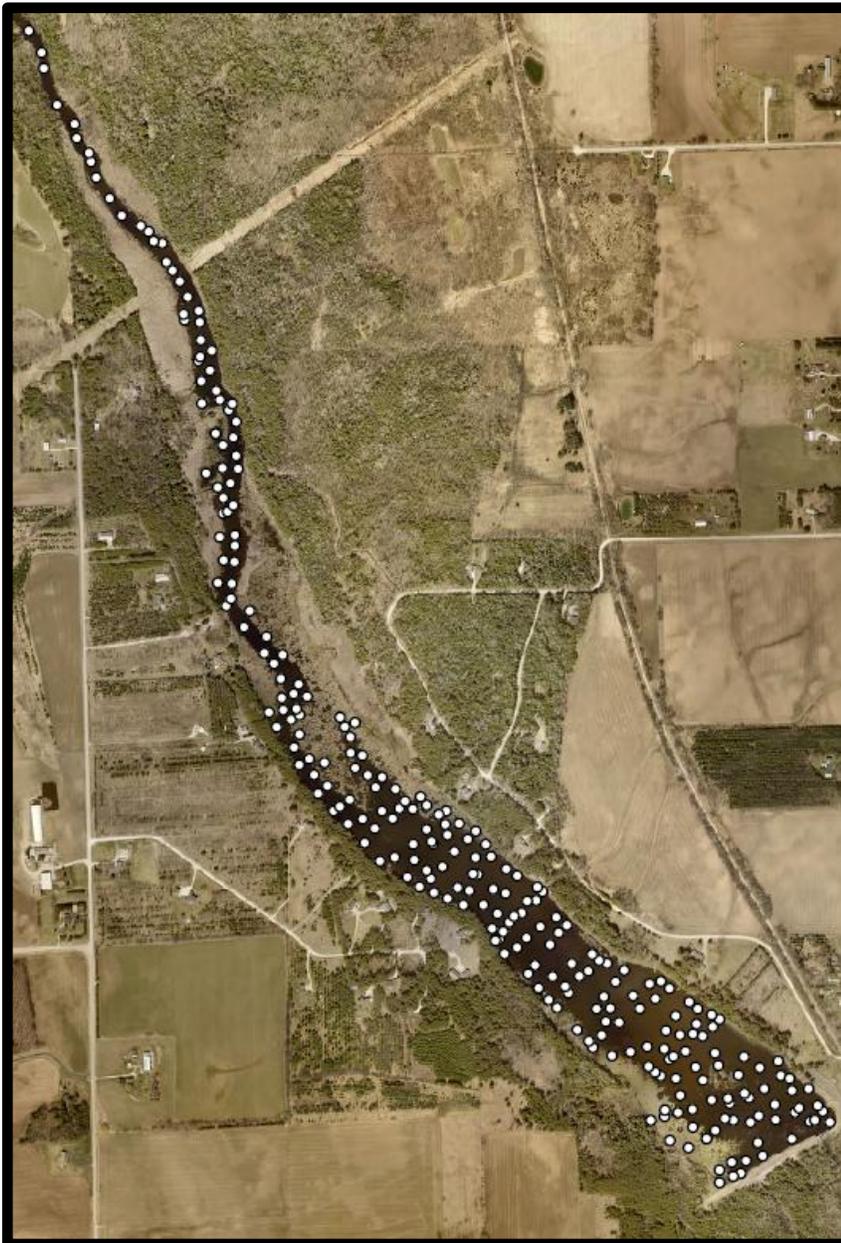
The post drawdown survey was performed to evaluate current conditions. 2023 efforts utilized the 2017 point-intercept grid design, evenly distributing sample sites across the lake surface. These sample sites were uploaded to a Carlson Surveyor+ data collector and staff navigated to each sample site, then recorded a corresponding sample point with sub-centimeter accuracy (Figure 19).

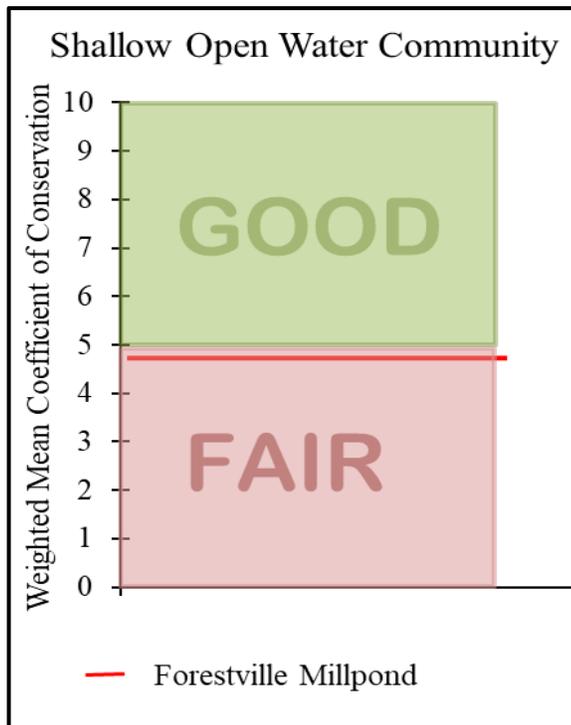
Figure 26. Weighted mean coefficient of conservatism ($w\bar{C}_n$) for the shallow open water ecological community in the Forestville Millpond compared to community assessments of a “good” or “fair” shallow open water community designated by the Minnesota Pollution Control Agency

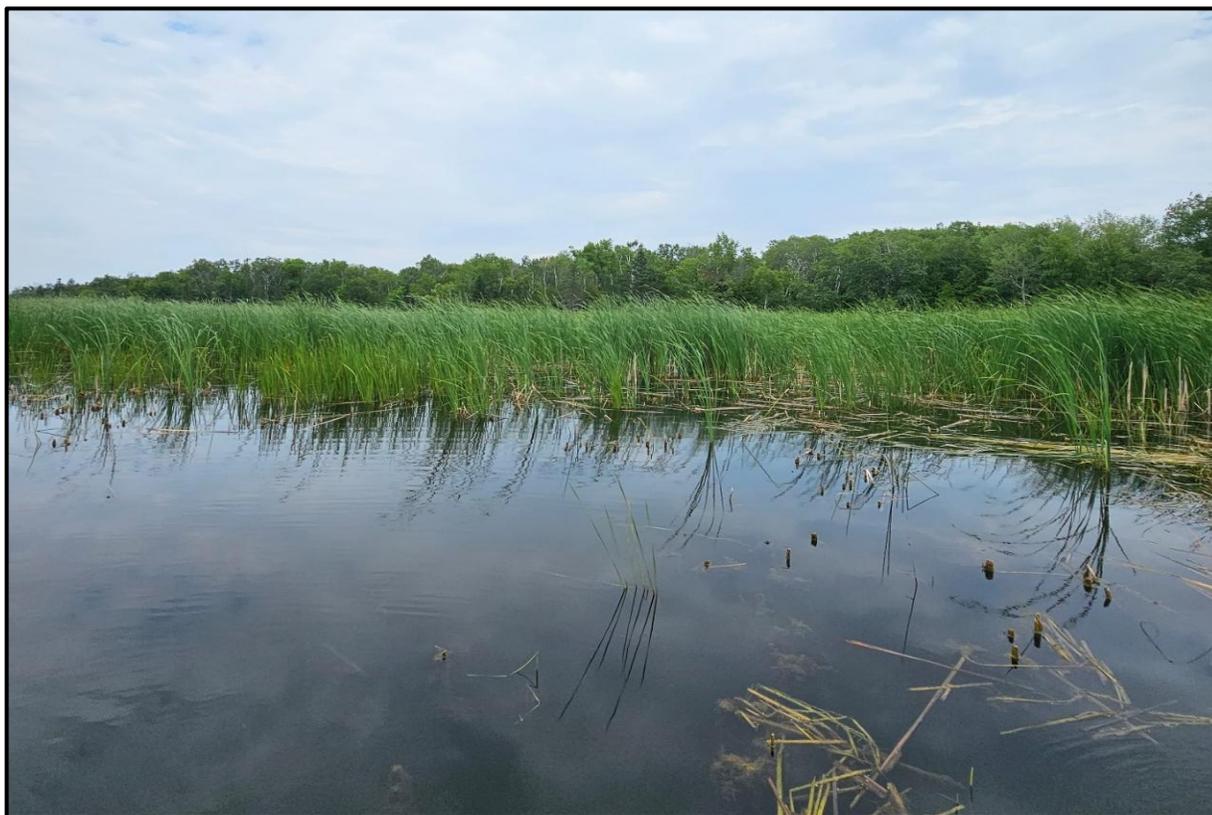
Figure 29. Photo of the convergence of the two observed ecological communities: open water and emergent marsh.

Cattails (*Typha sp.*) were abundant around the edge of the Millpond (Figure 29). These cattails were accompanied by bur-reed (*Sparganium eurycarpum*), softstem bulrush (*Schoenoplectus tabernaemontani*), spatterdock (*Nuphar variegata*), and small duckweed (*Lemna minor*), which all made up large portions of the emergent marsh habitat (Figure 21). While all these species may potentially be native, many cattail species are invasive in Door County. In this survey, cattail species were identified only to genus. Identification to species would require genetic testing to be absolute. Meaning populations identified may be invasive, hybrid, and/or native.
