# FINAL REPORT

Wisconsin Lake Management Planning Grant

FORESTVILLE MILLPOND

Prepared by:  
Door County Soil and Water  
Conservation Department

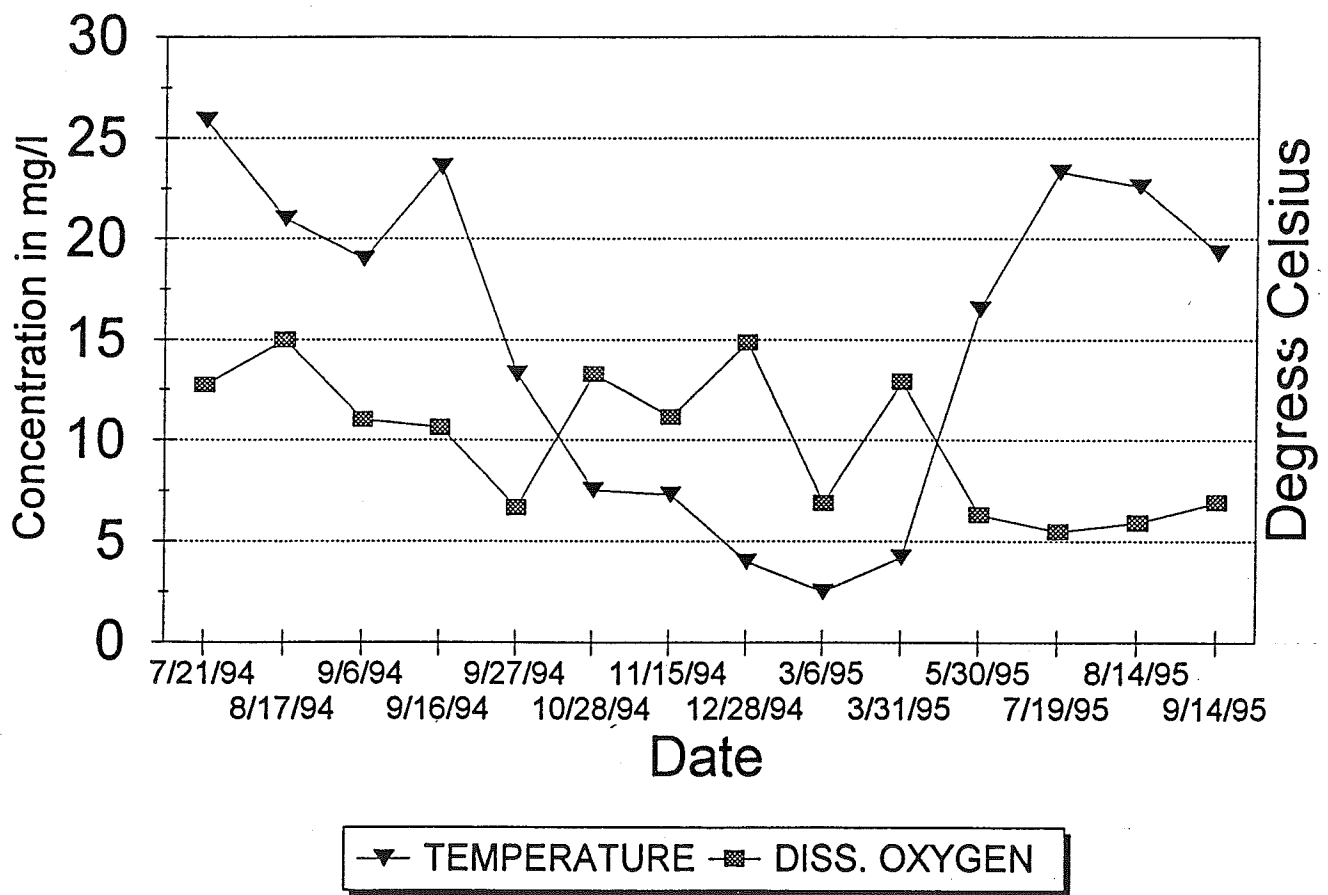
## FORESTVILLE MILLPOND (Site F1)

Dissolved Oxygen Vs Temperature

- A) Dissolved Oxygen: Dissolved oxygen (D.O.) is the most important parameter for the survival of aquatic organisms. Levels below 5.0 ppm (mg/l) will stress and kill some fish species and is the Wisconsin DNR legal standard for dissolved oxygen. Low D.O. levels also trigger the release of sediment held phosphorus, which in turn promotes summer algae blooms. Oxygen is produced when green aquatic plants grow in sunlight through a process called photosynthesis. When aquatic plants are not exposed to sunlight (nighttime, turbid or snow and ice covered conditions), carbon dioxide is produced and oxygen is used in a process called respiration. D.O. levels approached stressful levels on the following dates at the indicated depth for the Millpond (Site F1) <sup>1</sup>. The results indicate that dissolved oxygen is a problem in the Millpond (Attachments 5,6,&7).

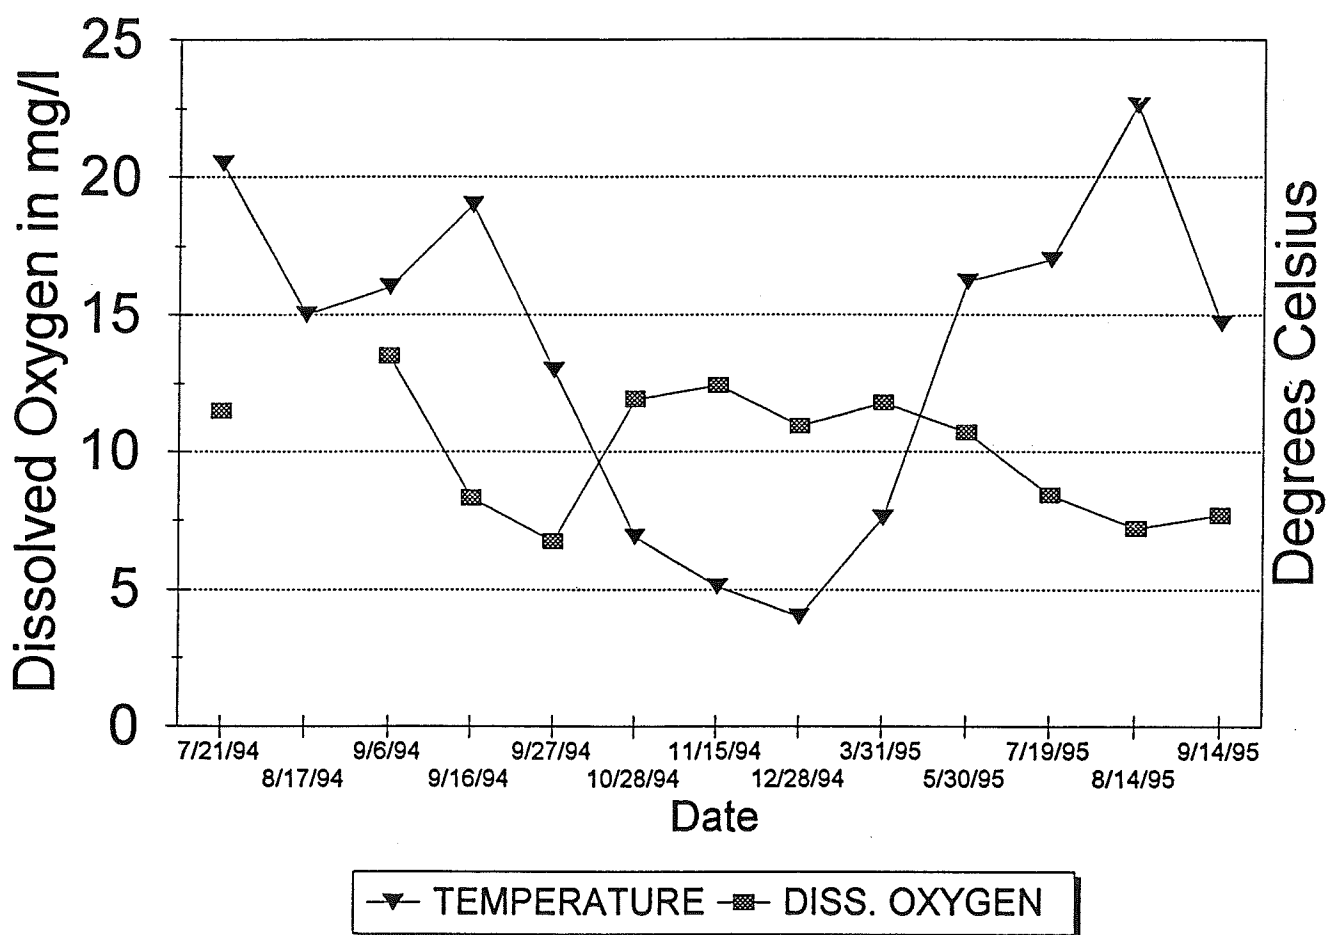
## FORESTVILLE MILLPOND (Site F3)

Dissolved Oxygen Vs Temperature

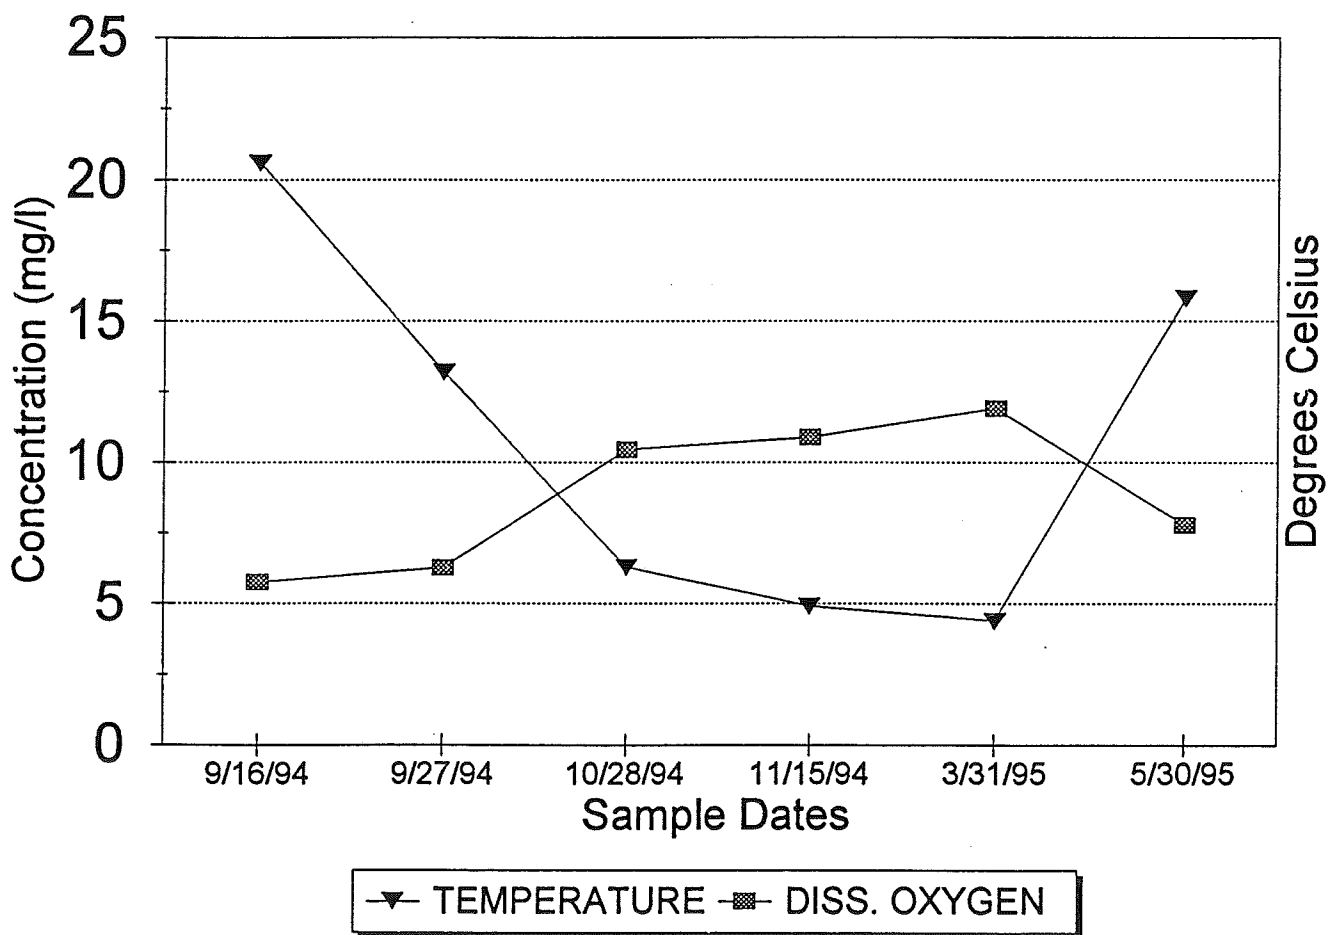
## FORESTVILLE MILLPOND (Site F4)

Dissolved Oxygen Vs Temperature

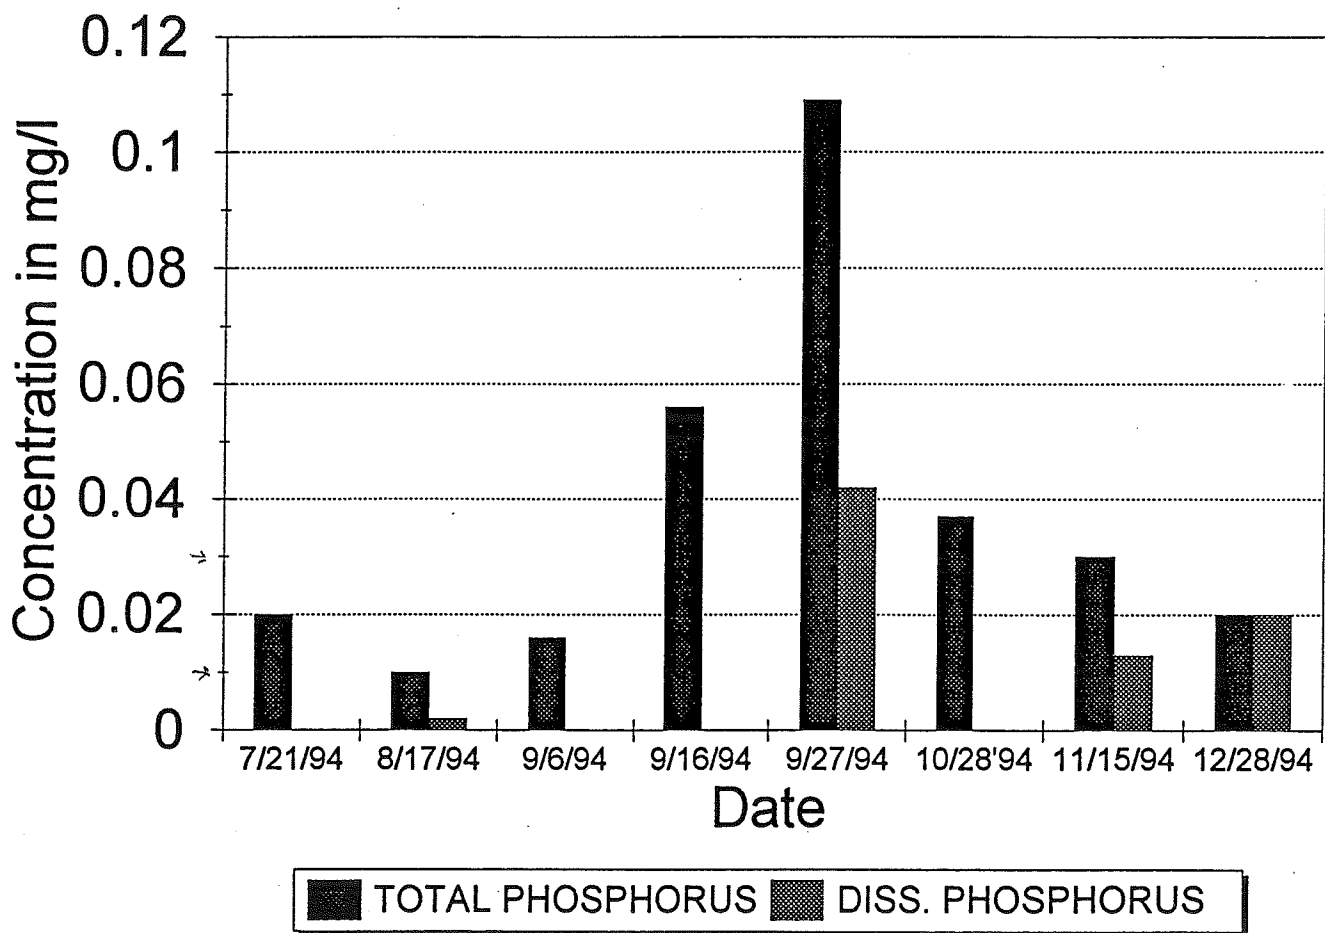
## FORESTVILLE MILLPOND (Site F3)

### Phosphorus Series

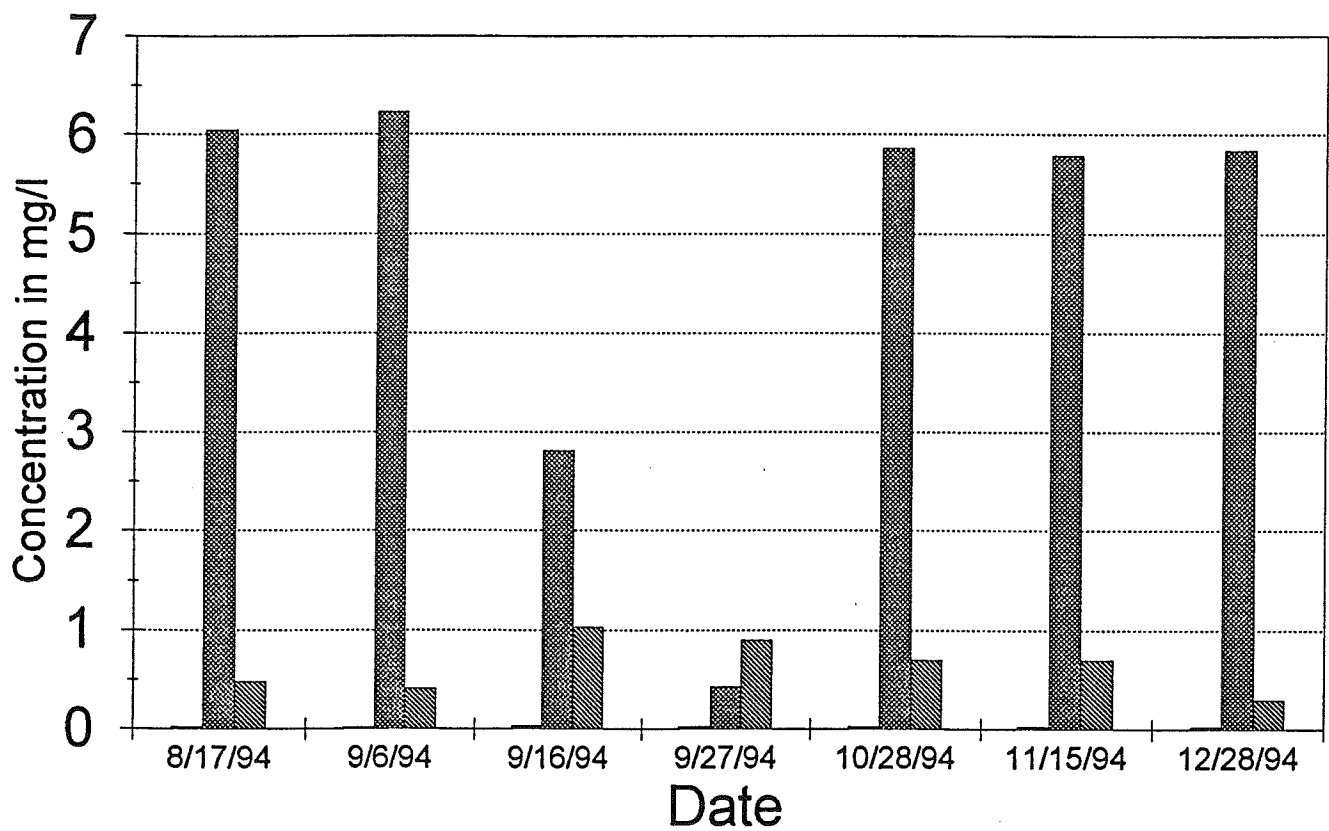
## FORESTVILLE MILLPOND (Site F3)

### Nitrogen Series

AMMONIA - N      NITRATE + NITRITE - N      TOTAL KJELDAHL - N

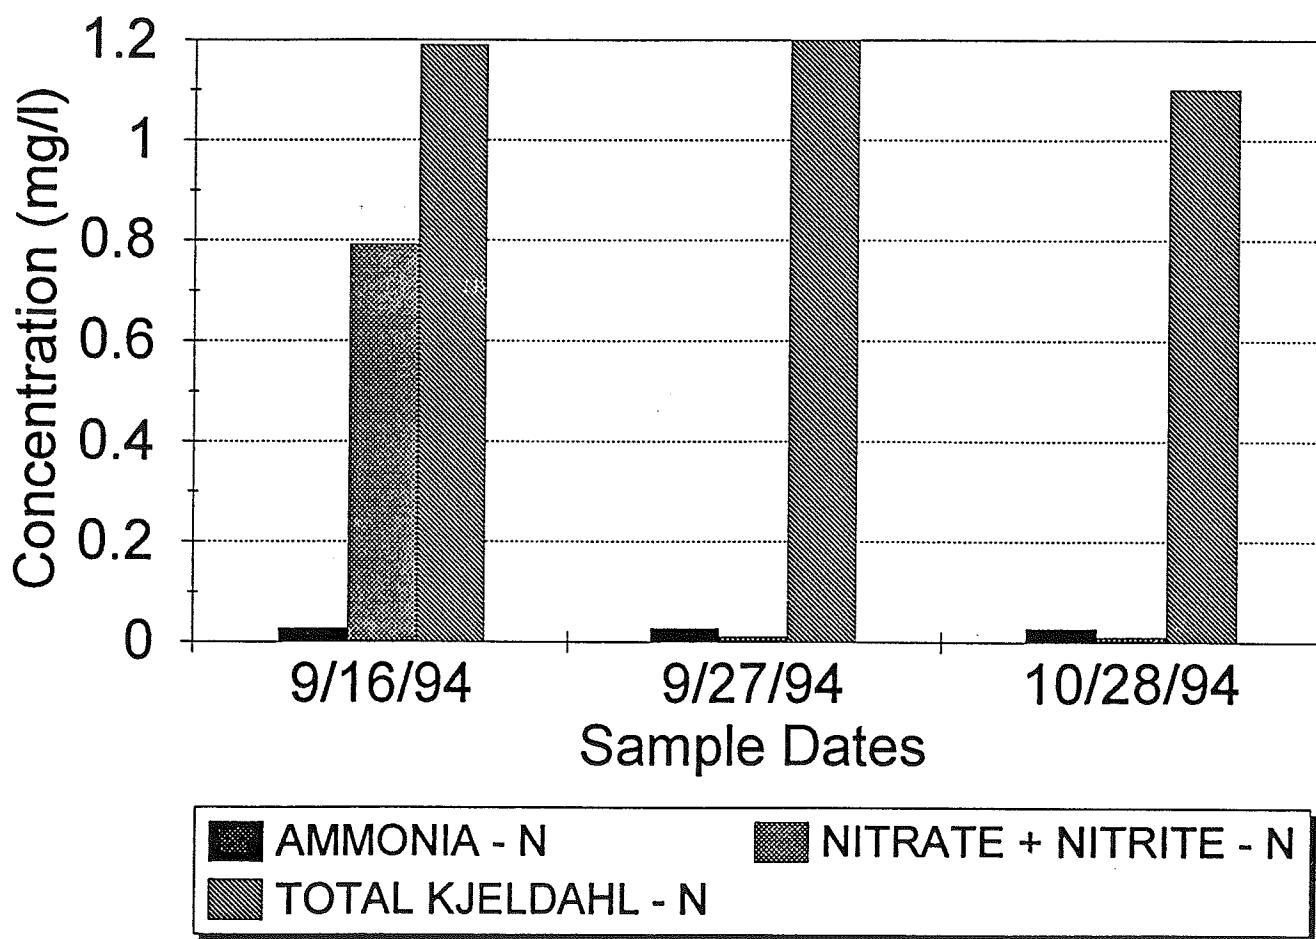
# FORESTVILLE MILLPOND (Site F4)

## Nitrogen Series

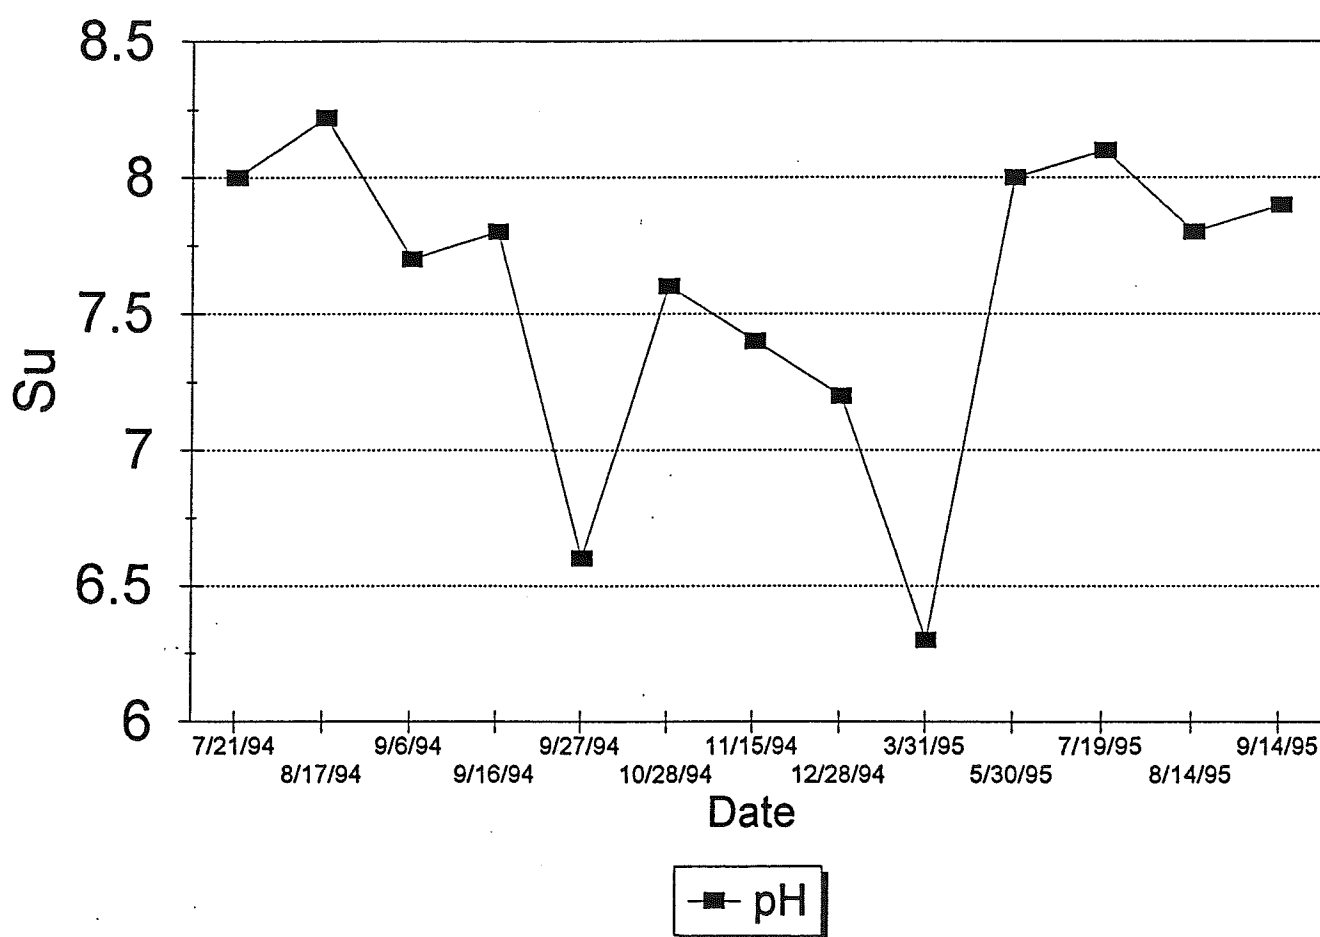
## FORESTVILLE MILLPOND (Site F3)

pH

NOTE: Su = Standard units for pH

- E) pH, Alkalinity and Hardness: Alkalinity and hardness are indicators for a lakes acid buffering capacity. Buffering increases with the presence of calcium or magnesium rich limestone deposits. If the pH were to drop below 5.0, the spawning of the Millpond fishery would be inhibited. At no time did the Millpond pH drop below 6.6. High levels of hardness (greater than 150 mg/l) and alkalinity can cause marl ( $\text{CaCO}_3$ ) to precipitate. Hard water lakes also have a tendency to control algae blooms by precipitating phosphorus with the marl. Alkalinity; however, is not a limiting factor for the proliferation of Eurasian water milfoil. The alkalinity level measured 252 mg/l and the hardness calculated out to 292 mg/l on March 31, 1995. See attachment 11 for pH test results.

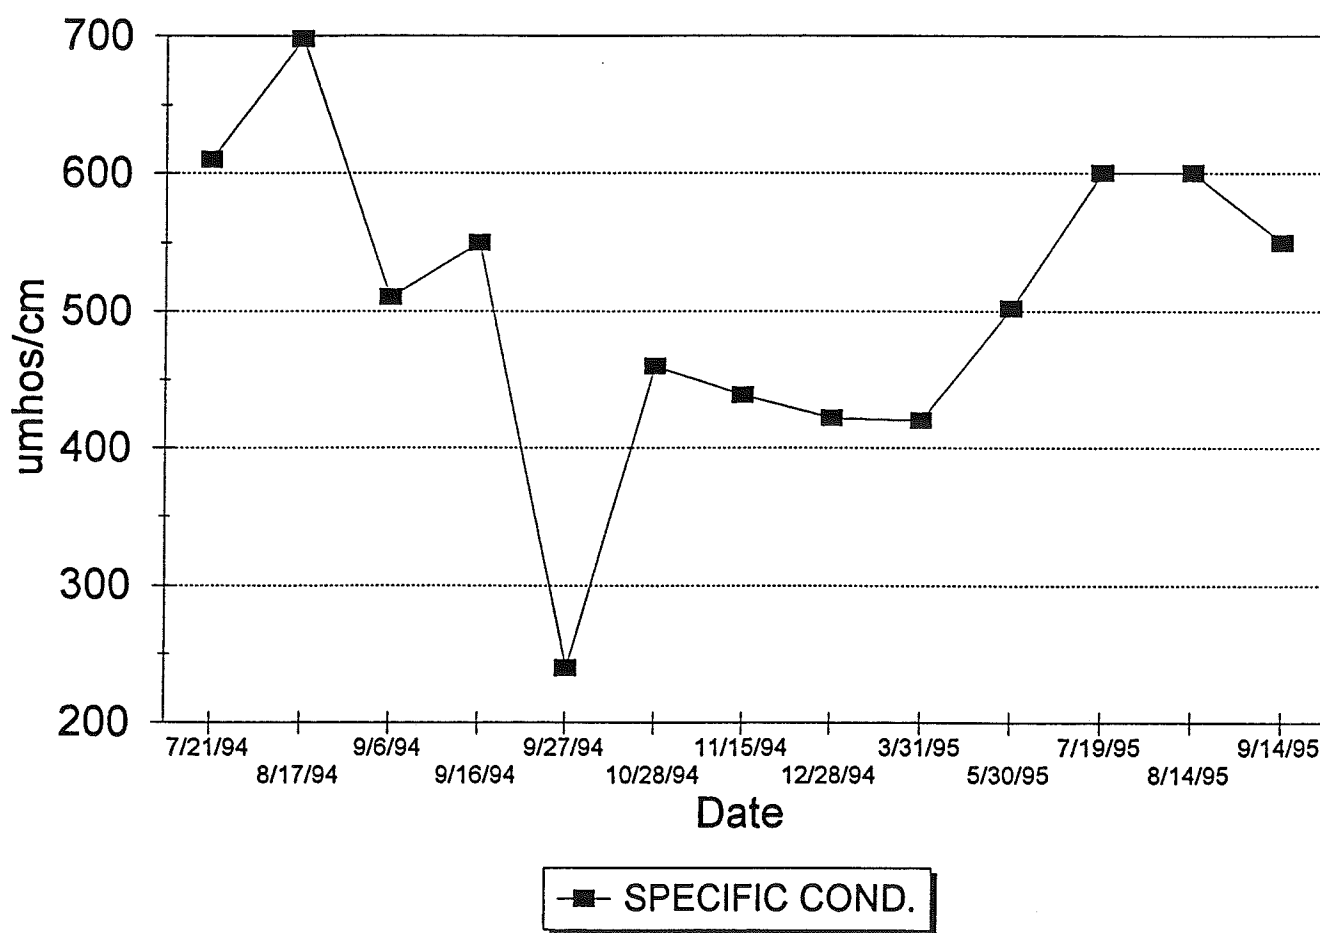
## FORESTVILLE MILLPOND (Site F3)

### Specific Conductivity

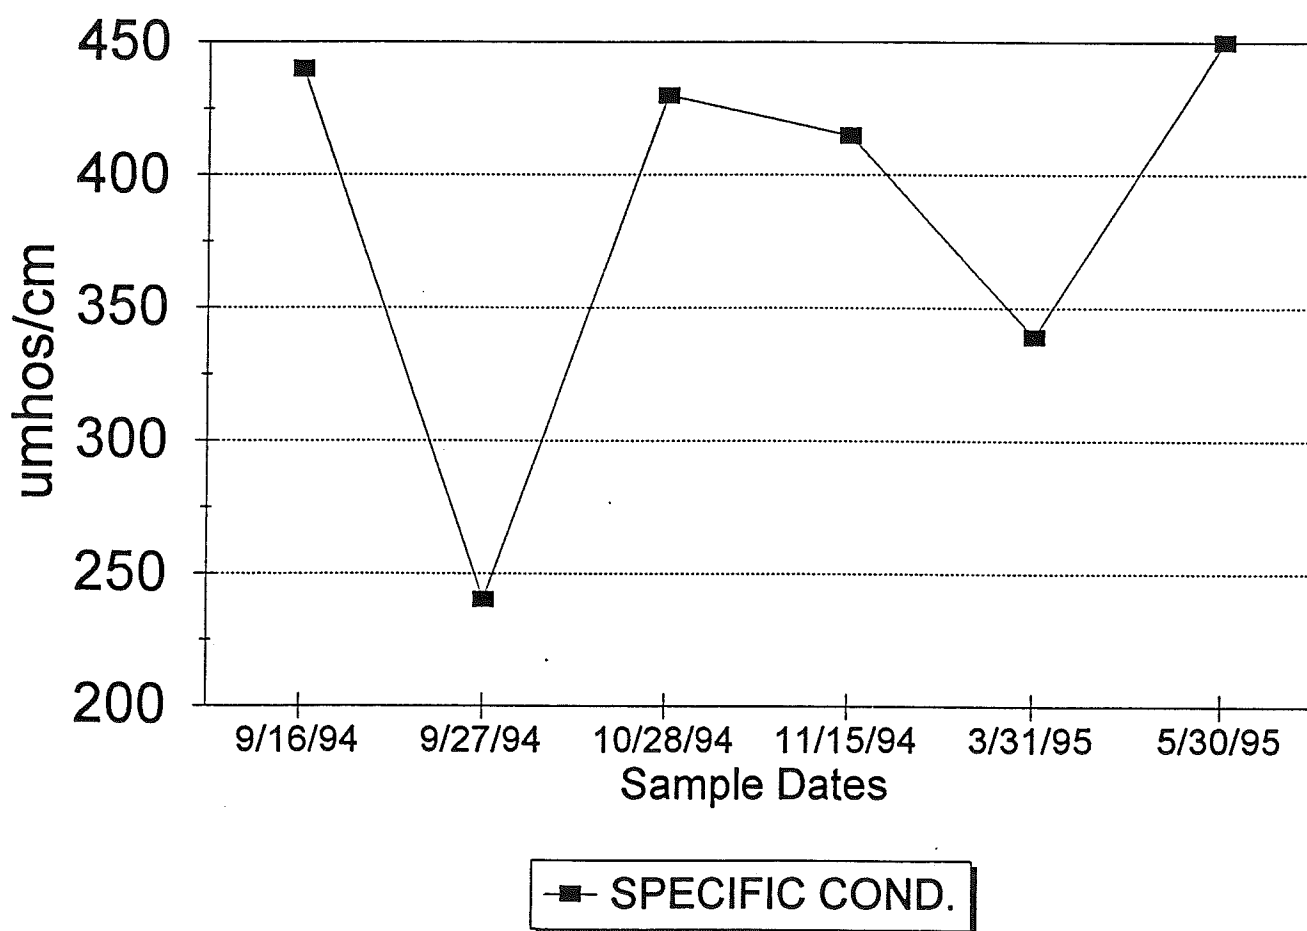
## FORESTVILLE MILLPOND (Site F4)

Specific Conductance

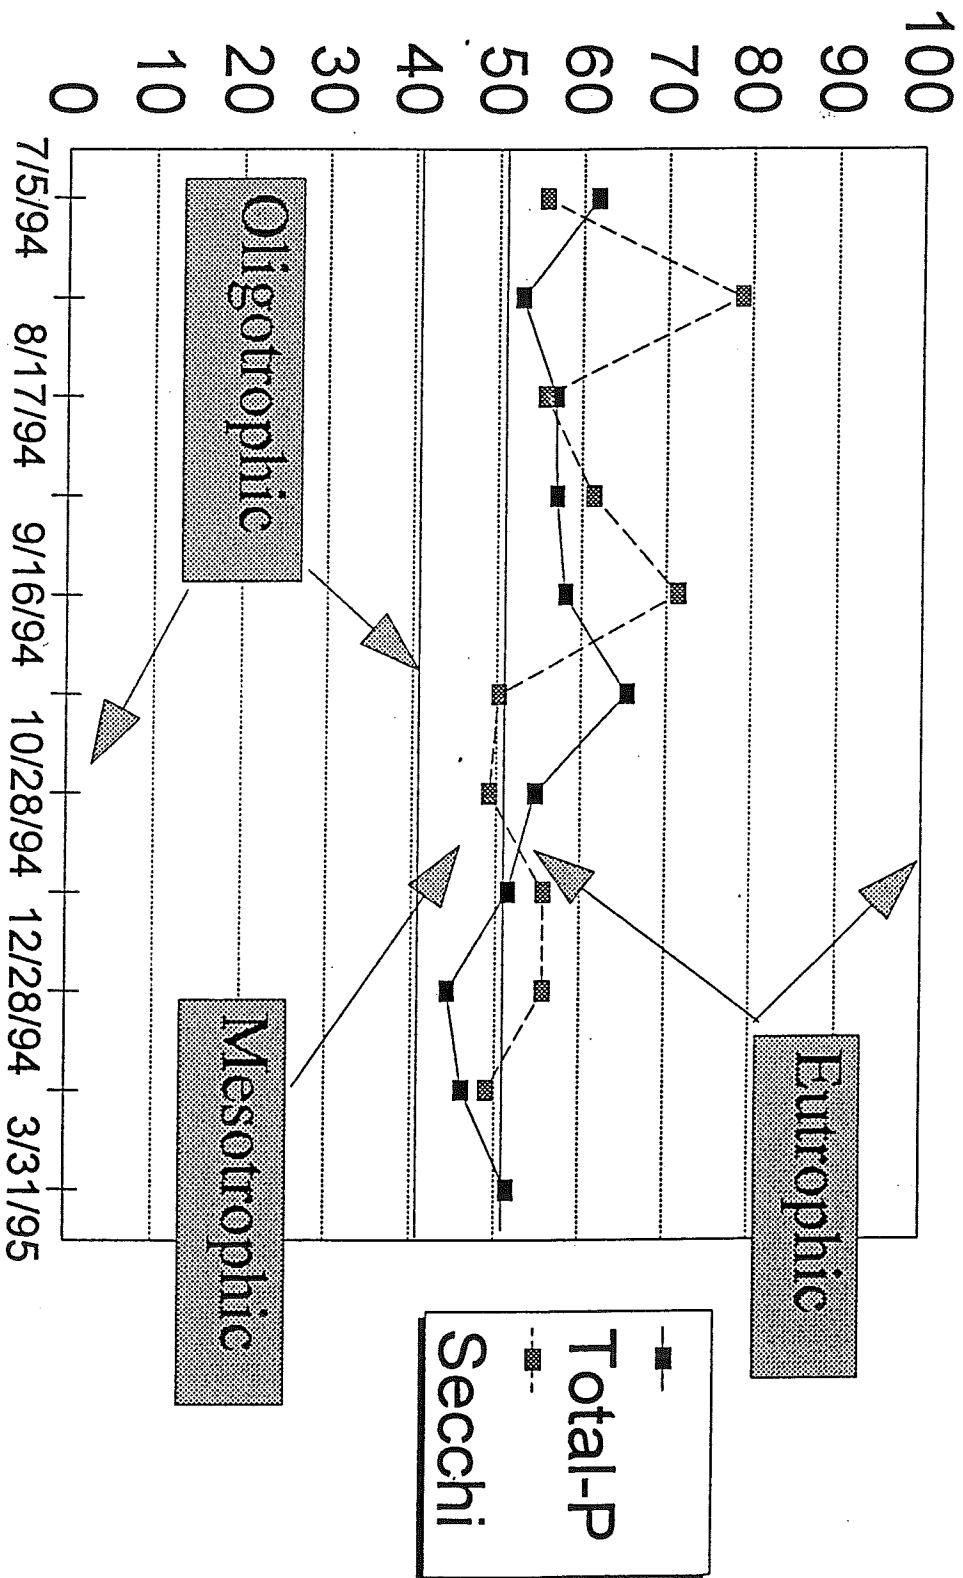
# Forestville Millpond Site F1

## Total-P & Secchi Trophic Values

Nonpoint sources of pollution have impacted the water quality of the Forestville Millpond. The Carlson's Trophic State Model (utilizing total phosphorus, water clarity and chlorophyll *a* as indicators of eutrophication - see attachment 15) indicates that the Millpond is in a eutrophic state. *Eutrophic* is a condition where waters are rich in organic nutrients, encouraging the proliferation of algae and other aquatic plants. This condition reduces dissolved oxygen and stresses or eliminates the capacity of the waterbody to support other organisms. Analysis of water and sediment samples support this finding.

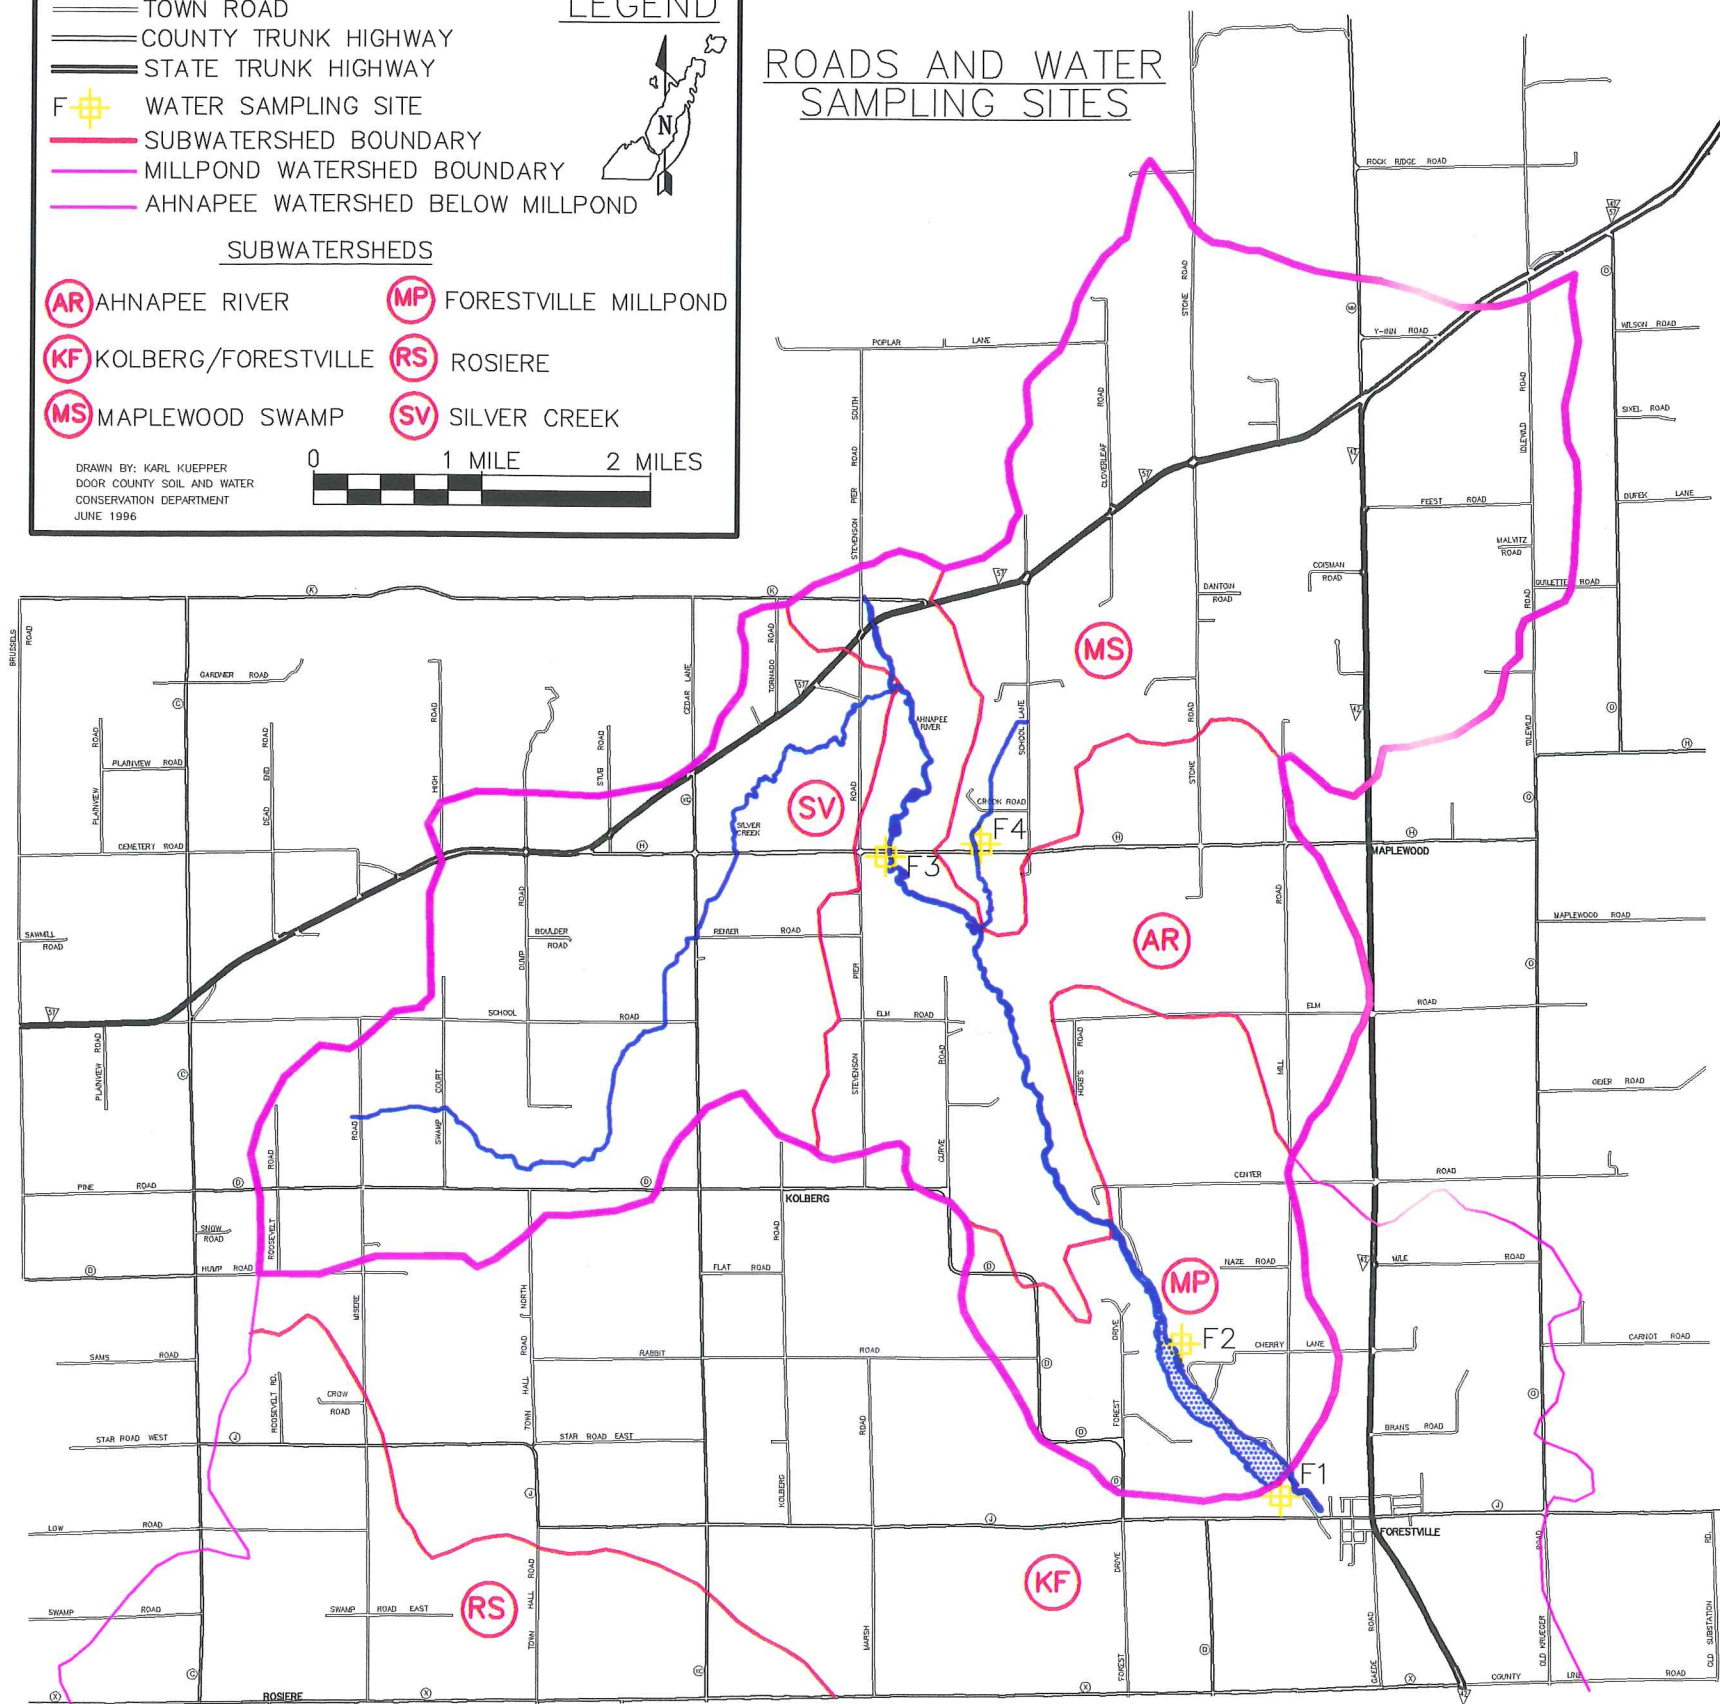
## ROADS AND WATER SAMPLING SITES

Four sample sites (F1, F2, F3 & F4) were selected to represent water flowing into and out of the Millpond (map 2). Site F1 is located in the deepest area of the Millpond, and is just above the dam. Site F2 was located where the Ahnapee River entered the Millpond. Site F2 was later discarded from the sampling schedule because of poor accessibility and repetitive analysis of water entering the Millpond. Site F3 is located at the intersection of County Highway H and the Ahnapee River. Site F4 is located 0.7 miles east of site F3 where an unnamed tributary to the Ahnapee intersects County Highway H. Refer to attachment 1 for test site locations.

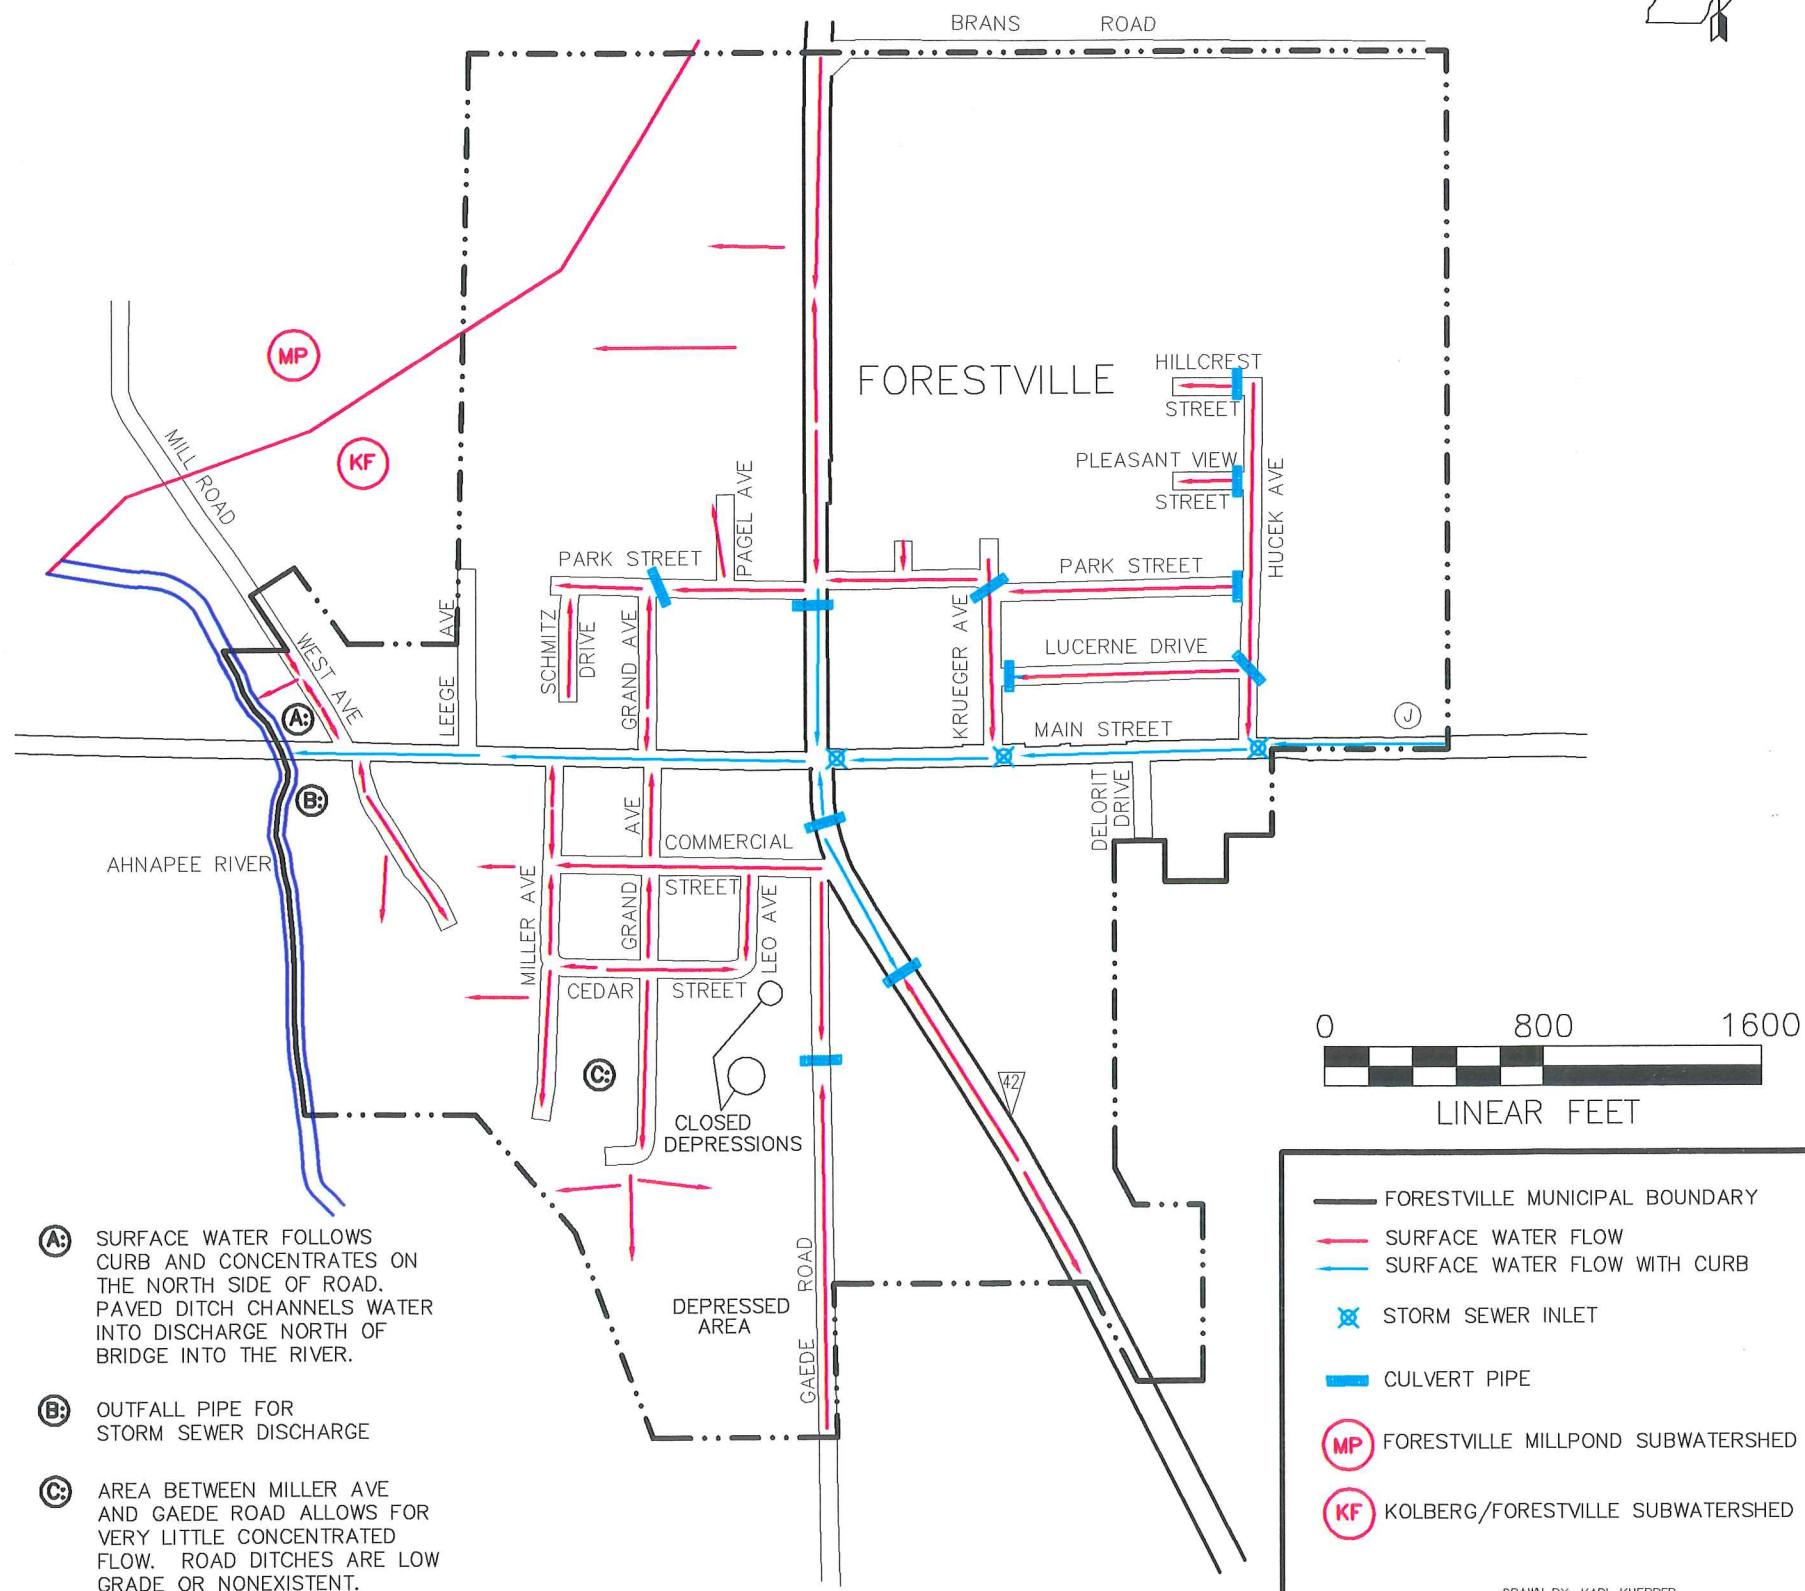
# VILLAGE OF FORESTVILLE SURFACE WATER ROUTING

Two storm and runoff events were studied in the village of Forestville during the autumn of 1995. Direction, destination and flow types were noted to generate a routing map (map 5). The map was then used to determine if urban runoff impacts the Millpond.

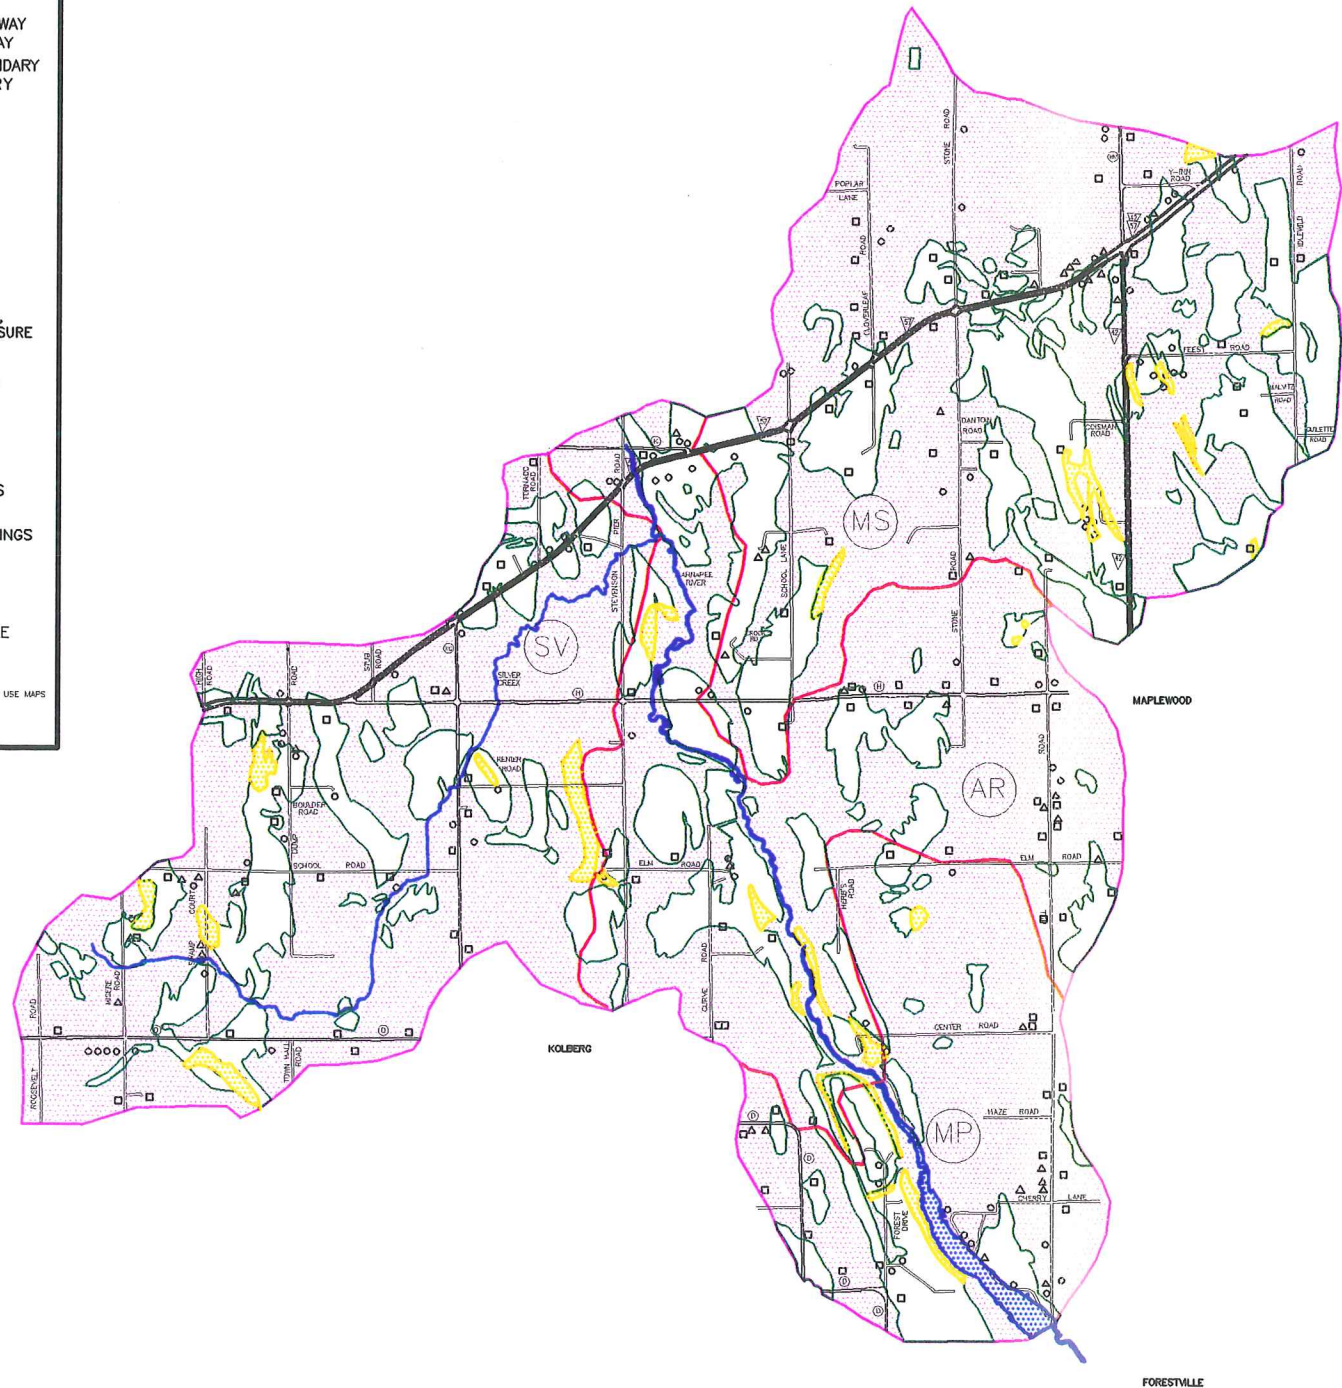
SOILS WITH SEPTIC SYSTEM LIMITATIONS  
AND OCCUPIED DWELLINGS

Failing or improperly located septic systems are a greater concern to groundwater than surface water. The soils within the watershed were evaluated for their suitability to septic systems common to Door County. Criteria used for the analysis included *depth to bedrock* and *hydro groupings* as determined by the Door County Soil Survey<sup>4</sup>. The study showed that approximately 70% of the watershed is considered unsuitable for conventional, mound and in-ground pressure septic systems (leaving holding tanks as the only waste water option). Of the 219 year-round and seasonal residences in the watershed, 145 exist in this area, many of which still use conventional septic systems. (Note: an inventory of *existing septic systems in use* was not a part of this study; thus, exact numbers are not available.) Another 2% of the area is considered unsuitable for conventional septic systems but are suitable for in-ground pressure septic systems. Only about 28% of the total land area is suitable for conventional septic systems (map 6).
